# **PROBLEMS CAUSES CURES**

Designed to help you solve Hardwood Flooring Problems

Wood Floors:

The Problem, The Cause and The Cure

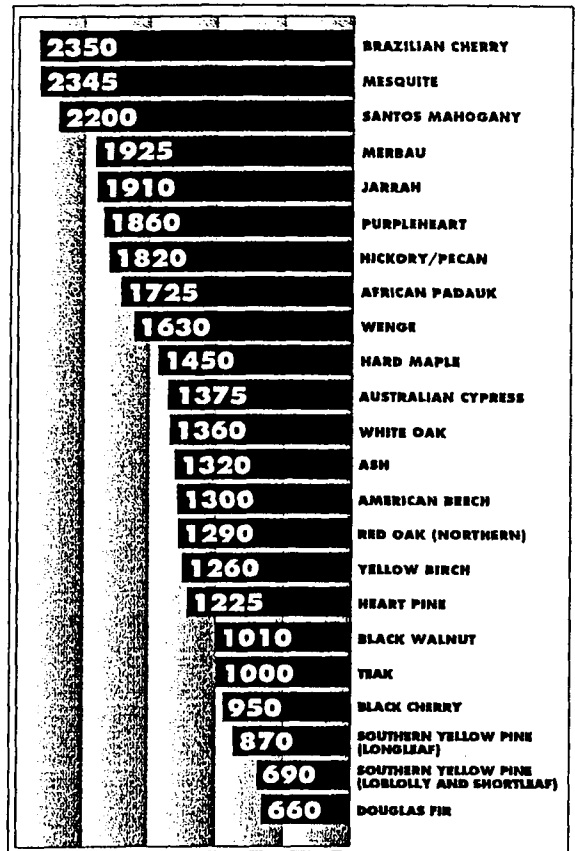
The Janka (or side) hardness test measures the force required to embed a .444-inch steel ball to half its diameter in wood. It is one of the best measures of the ability of a wood species to withstand denting and wear. By the same token, it is also a good indicator of how hard or easy a species is to saw or nail. Northern red oak, for example, has a Janka hardness rating of 1290. Brazilian cherry, with a rating of 2350, is nearly twice as hard. If you're accustomed to working with red oak and decide to tackle a job with Brazilian cherry, you can expect it to be much harder to cut and nail.

- Source: Hardness ratings for most species taken from Wood Handbook: Wood as an Engineering Material (Agriculture Handbook 72, Forest Products Laboratory, Forest Service, U.S. Department of Agriculture; revised 1987), except for Australian cypress, wenge, African padauk, merbau and Santos mahogany, which were provided by International Hardwood Flooring; heart pine by Mountain Lumber, and mesquite by Mesquite Products of Texas.
- Douglas fir rating is an average of ratings for Coast, Interior West and Interior North species.

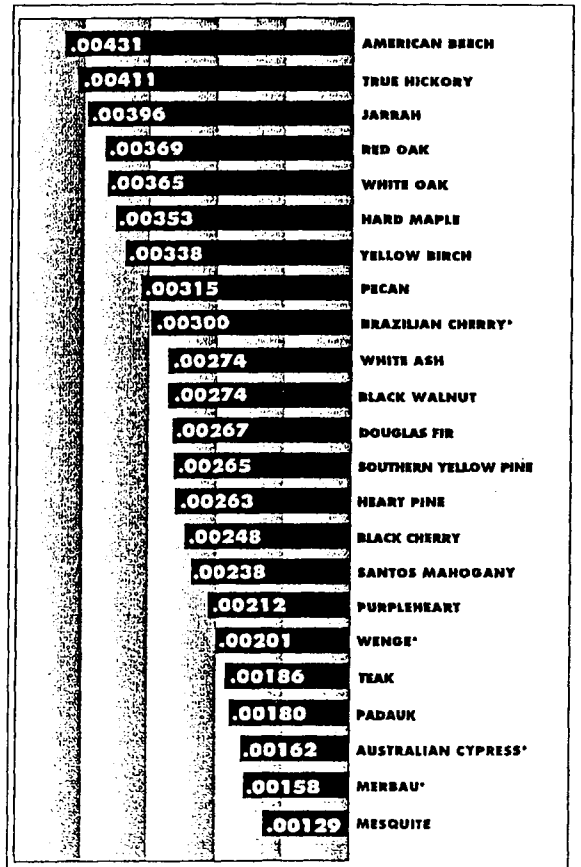
## RELATIVE STABILITY OF SELECTED WOOD FLOORING SPECIES

(Ranked by dimensional change coefficient)

The numbers in the chart reflect the dimensional change coefficient for the various species, measured as tangential shrinkage or swelling within normal moisture content limits of 6-14 percent. Tangential change values will normally reflect changes in plainsawn wood. Quartersawn wood will usually be more dimensionally stable than plainsawn.

The dimensional change coefficient can be used to calculate expected shrinkage or swelling. Simply multiply the change in moisture content by the change coefficient, then multiply by the width of the board.

Example: A mesquite (change coefficient = .00129) board 5 inches wide experiences a moisture content change from 6 to 9 percent — a change of 3 percentage points.

The chart is best used for comparison.

\* Although some tropical woods such as Australian cypress, Brazilian cherry, merbau and wenge appear in this chart to have excellent moisture stability compared to domestic oak, actual installations of many of these woods have demonstrated significant movement in use. To avoid problems later, extra care should be taken to inform potential users of these tendencies prior to purchase.

• Source: Stability ratings taken from Wood Handbook: Wood as an Engineering Material (Agriculture Handbook 72, Forest Products Laboratory, Forest Service, U.S. Department of Agriculture; revised 1987).
